**Flood Control Project Maintenance
Levee Inspections****LMA District Cover Sheet****Spring 2013 Levee Inspection Results****Reclamation District No. 0785 Driver**

Levee Inspection Report By Mile - Spring 2013

Reclamation District No. 0785 Driver

Waterway				Bank	Unit Miles	Inspection Start/End	Inspector
Unit No. 01 Sacramento River				Right	2.31		John Williamson

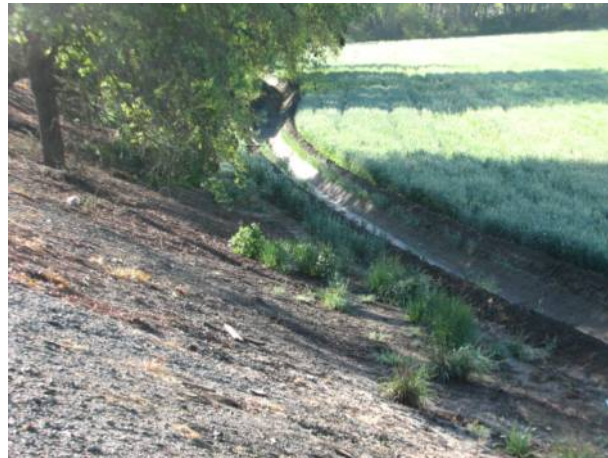
Levee Mile Report Line	4
Start Levee Mile	0.07
End Levee Mile	0.31
Location	Land Side
Category	
Item	Encroachments

The agricultural ditch is along the toe of the levee. Spring 2013

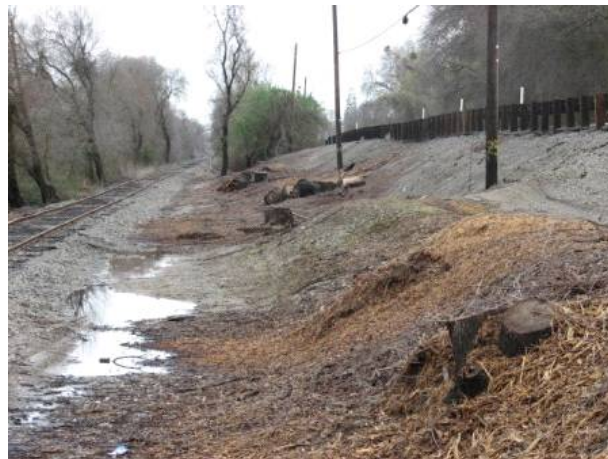
Levee Mile Report Line	5
Start Levee Mile	0.13
End Levee Mile	1.36
Location	Land Side
Category	
Item	Trim / Thin Trees

The trees were cut by PG&E'S tree contractor. The district will take care of the stumps in the future.

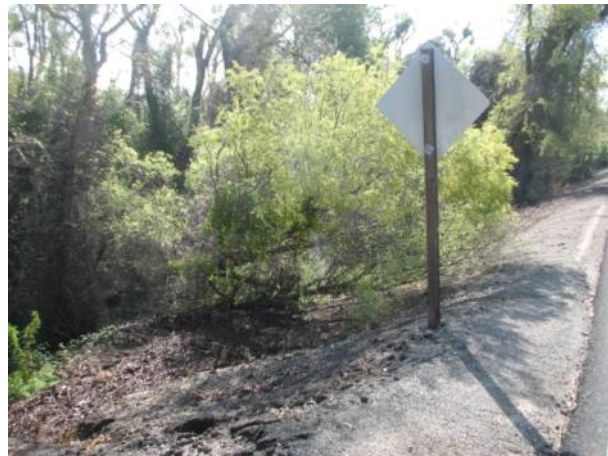
Levee Mile Report Line	6
Start Levee Mile	0.25
End Levee Mile	0.25
Location	Water Side
Category	
Item	Trim / Thin Trees

The tree on the waterside has fallen on the levee slope. Spring 2013

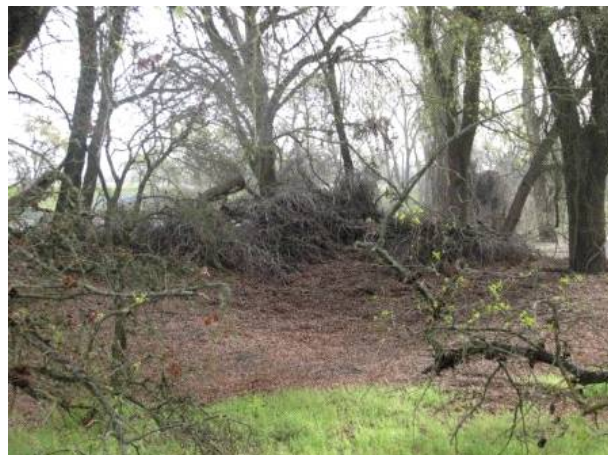
Levee Mile Report Line	9
Start Levee Mile	0.68
End Levee Mile	0.68
Location	Land Side
Category	
Item	Encroachments
A pruning pile is on the landside of the levee slope, photo taken spring 2012.	
johngw_s_20130221_416.jpg

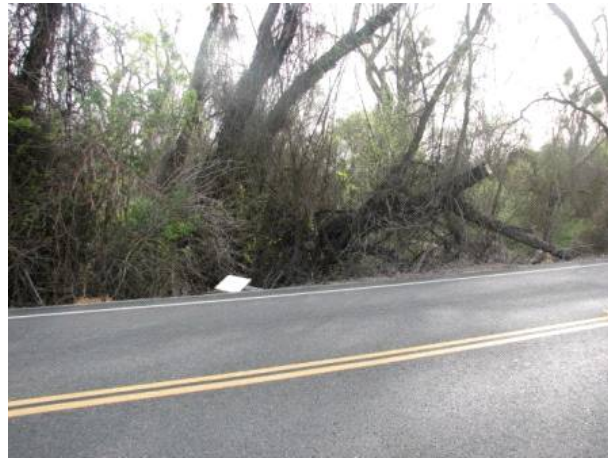
Levee Mile Report Line	11
Start Levee Mile	0.93
End Levee Mile	0.93
Location	Water Side
Category	
Item	Trim / Thin Trees

The fallen tree and brush on the waterside of the roadway needs to be removed. Photo taken spring 2012.

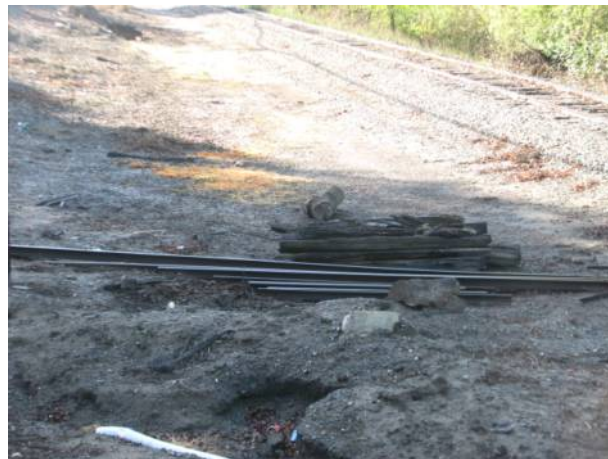
Levee Mile Report Line	12
Start Levee Mile	1.08
End Levee Mile	1.08
Location	Land Side
Category	
Item	Encroachments

Railroad ties and rails lay along the toe of the levee. Spring 2013

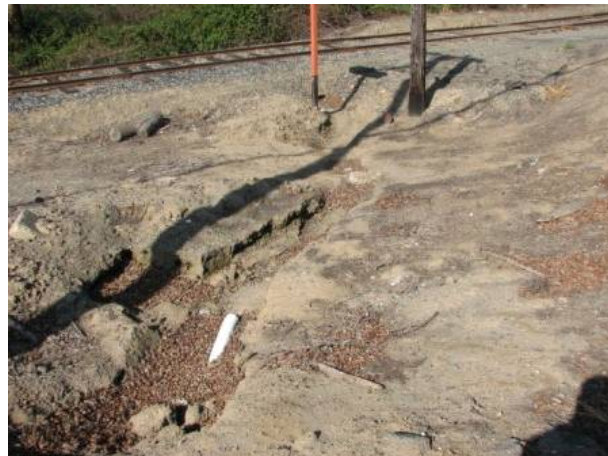
Levee Mile Report Line	13
Start Levee Mile	1.08
End Levee Mile	1.08
Location	Land Side
Category	
Item	Erosion / Bank Caving

The drain pipe across from the firehouse has caused erosion, photo taken spring 2012.

DWR ID: DWR_RD0785_01_s_2012_47									
12	1.08	1.08		Encroachments	LS M En	DE : Debris	38.649355 ° -121.601760 °	38.649355 ° -121.601760 °	12 Y
DWR ID: DWR_RD0785_01_s_2013_12									
13	1.08	1.08		Erosion / Bank Caving	LS M Ma	E2 : Schedule repair of erosion site prior to the next inspection.	38.649292 ° -121.601647 °	38.649292 ° -121.601647 °	48 Y
DWR ID: DWR_RD0785_01_s_2012_48									
14	1.32	1.32		Vegetation	LS A/W Ma	V4 : Elderberries are blocking visibility and flood fight capability.	38.646712 ° -121.599095 °	38.646712 ° -121.599095 °	6 Y
DWR ID: DWR_RD0785_01_s_2012_6

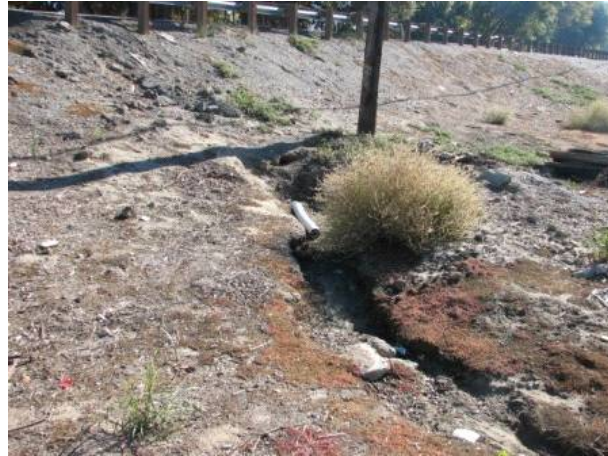
Levee Mile Report Line	13
Start Levee Mile	1.08
End Levee Mile	1.08
Location	Land Side
Category	
Item	Erosion / Bank Caving
Erosion on the levee slope and toe. Fall 2012	
johngw_s_20130221_419.jpg

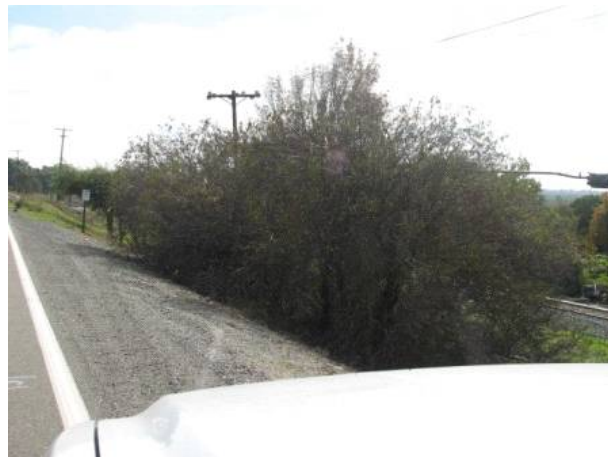
Levee Mile Report Line	14
Start Levee Mile	1.32
End Levee Mile	1.32
Location	Land Side
Category	
Item	Vegetation
This is a very large Elderberry bush.	
johngw_s_20130221_414.jpg

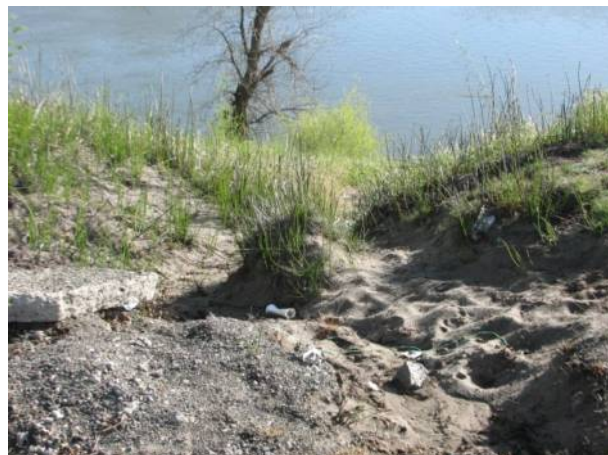
Levee Mile Report Line	15
Start Levee Mile	1.32
End Levee Mile	1.32
Location	Water Side
Category	
Item	Erosion / Bank Caving
The waterside levee slope has erosion from surface run off. Spring 2013	
johngw_s_20130408_895.JPG

LMR No.	Levee Mile		Category	Item	Location *	Rating **	Action/Comment	GPS Latitude/Longitude		Issue No.
	Start	End						Start	End	
15	1.32	1.32		Erosion / Bank Caving	WS	M _{Ma}	E2 : Schedule repair of erosion site prior to the next inspection.	38.646671 ° -121.598915 °	38.646671 ° -121.598915 °	13 Y
DWR ID: DWR_RD0785_01_s_ 2013_13										
16	2.04	2.14		Vegetation	LS	M _{En}	V6 : Landscaping Inspector Comments: Trees have been raised for visibility. Pine trees and oleander planted on shoulder.	38.641623 ° -121.588558 °	38.642005 ° -121.586993 °	8 Y
DWR ID: DWR_RD0785_01_s_ 2012_8

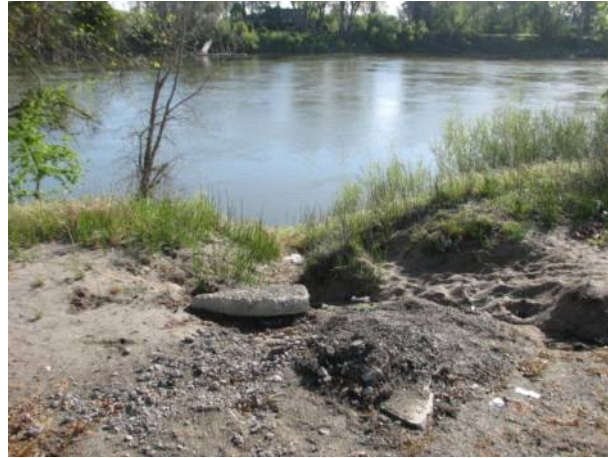
Levee Mile Report Line	15
Start Levee Mile	1.32
End Levee Mile	1.32
Location	Water Side
Category	
Item	Erosion / Bank Caving

The erosion has become a trail for fishermen and contributes to it. Spring 2013

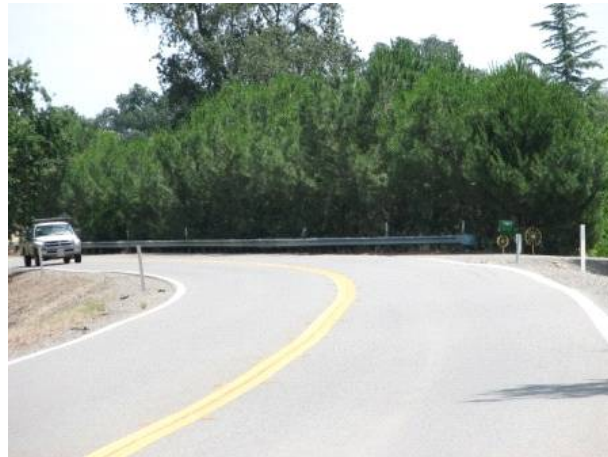
Levee Mile Report Line	16
Start Levee Mile	2.04
End Levee Mile	2.14
Location	Land Side
Category	
Item	Vegetation

Pines and oleanders along shoulder.

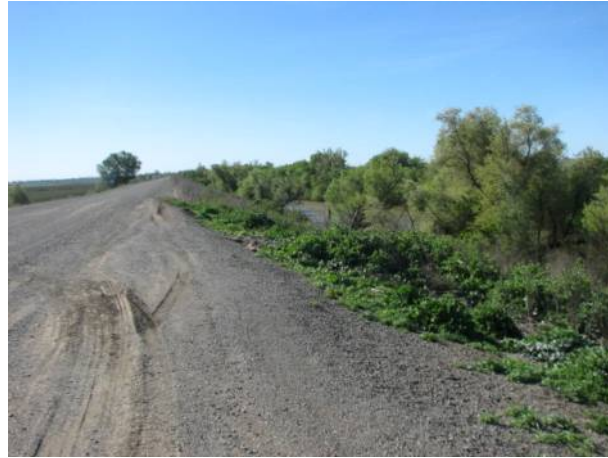
Levee Mile Report Line	1
Start Levee Mile	0.01
End Levee Mile	0.62
Location	Water Side
Category	
Item	Vegetation
The vegetation is taller then 12". Spring 2013	
johngw_s_20130415_928.JPG

LMR No.	Levee Mile		Category	Item	Location * + Rating	Action/Comment	GPS Latitude/Longitude		Issue No. Photo
	Start	End					Start	End	
1	0.01	0.62		Vegetation	WS M Ma	V2 : Remove the wild growth other than native grasses from the levee slopes.	38.640913 ° -121.620295 °	38.632923 ° -121.615440 °	2 Y
DWR ID: DWR_RD0785_02_f_2012_2									
2	0.04	0.62		Vegetation	LS M Ma	V2 : Remove the wild growth other than native grasses from the levee slopes.	38.640603 ° -121.620026 °	38.632907 ° -121.615463 °	1 Y
DWR ID: DWR_RD0785_02_f_2012_1									
3	0.11	0.11		Animal Control	LS M Ma	A3 : No rodents visible, but rodent burrows visible; need to backfill and compact or grout burrows. Inspector Comments: Unable to see slope.	38.639670 ° -121.619460 °	38.639670 ° -121.619460 °	25 Y
DWR ID: DWR_RD0785_02_s_2012_25									
4	0.24	0.24		Animal Control	LS M Ma	A3 : No rodents visible, but rodent burrows visible; need to backfill and compact or grout burrows. Inspector Comments: Unable to see slope.	38.637913 ° -121.618388 °	38.637913 ° -121.618388 °	26 Y

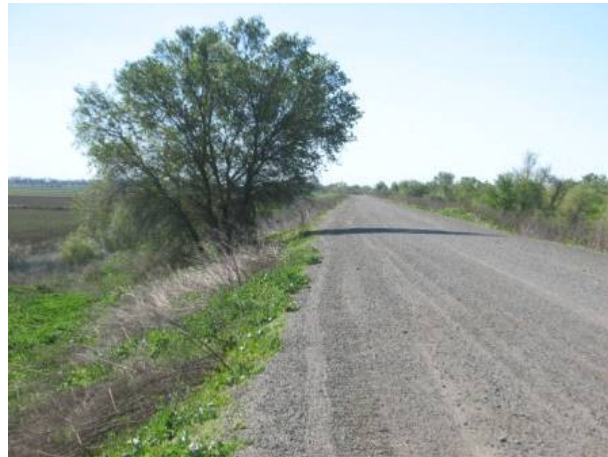
Levee Mile Report Line	2
Start Levee Mile	0.04
End Levee Mile	0.62
Location	Land Side
Category	
Item	Vegetation
The vegetation is thaller then 12". Spring 2013	
johngw_s_20130415_929.JPG

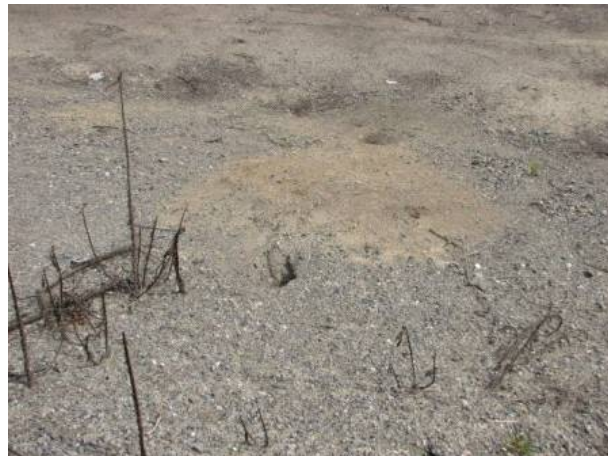
Levee Mile Report Line	3
Start Levee Mile	0.11
End Levee Mile	0.11
Location	Land Side
Category	
Item	Animal Control
Rodent holes on the landside levee slope, photo taken spring 2012.	
johngw_s_20130221_422.jpg

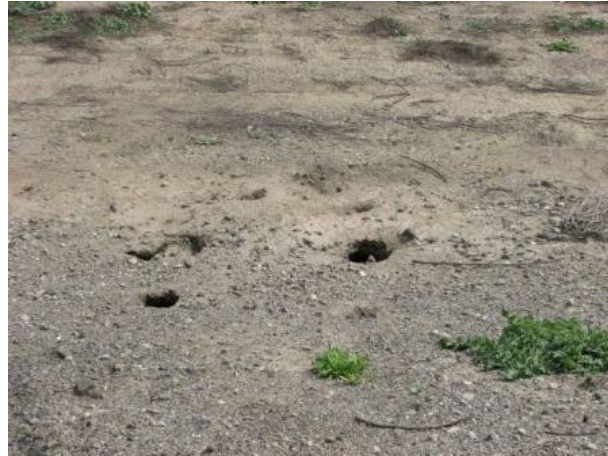
Levee Mile Report Line	5
Start Levee Mile	0.38
End Levee Mile	0.38
Location	Land Side
Category	
Item	Animal Control

Rodent holes on the landside levee slope, photo taken spring 2012.

DWR ID: DWR_RD0785_02_s_2012_26									
5	0.38	0.38		Animal Control	LS A/W Ma	A3 : No rodents visible, but rodent burrows visible; need to backfill and compact or grout burrows. Inspector Comments: Unable to see slope.	38.636065 ° -121.617295 °	38.636065 ° -121.617295 °	27 Y
DWR ID: DWR_RD0785_02_s_2012_27									
6	0.46	0.46		Animal Control	LS A/W Ma	A3 : No rodents visible, but rodent burrows visible; need to backfill and compact or grout burrows. Inspector Comments: Unable to see slope.	38.634978 ° -121.616612 °	38.634978 ° -121.616612 °	28 Y
DWR ID: DWR_RD0785_02_s_2012_28									
7	0.52	0.52		Slope Stability	LS M Ma	S1 : Repair slope instability.	38.634180 ° -121.616142 °	38.634180 ° -121.616142 °	29 Y
DWR ID: DWR_RD0785_02_s_2012_29									
8	0.64	3.29		Vegetation	LS A Ma	V1 : Control annual grass and weeds on the levee slopes and easements.	38.632636 ° -121.615272 °	38.599586 ° -121.590309 °	4 Y

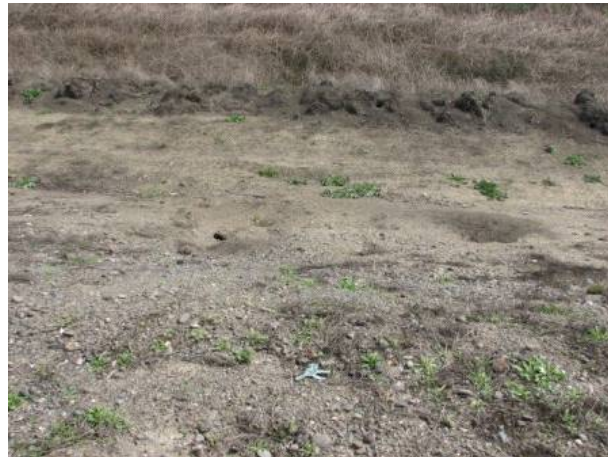
Levee Mile Report Line	6
Start Levee Mile	0.46
End Levee Mile	0.46
Location	Land Side
Category	
Item	Animal Control

Rodent holes on the landside levee slope, photo taken spring 2012.

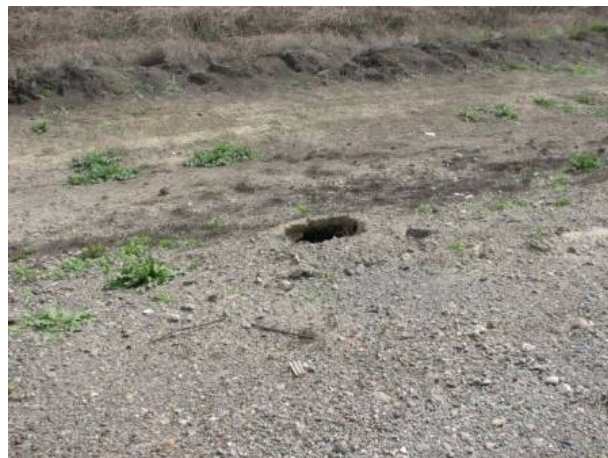
Levee Mile Report Line	6
Start Levee Mile	0.46
End Levee Mile	0.46
Location	Land Side
Category	
Item	Animal Control

Many rodent holes with in 25' of each other, photo taken spring 2012.

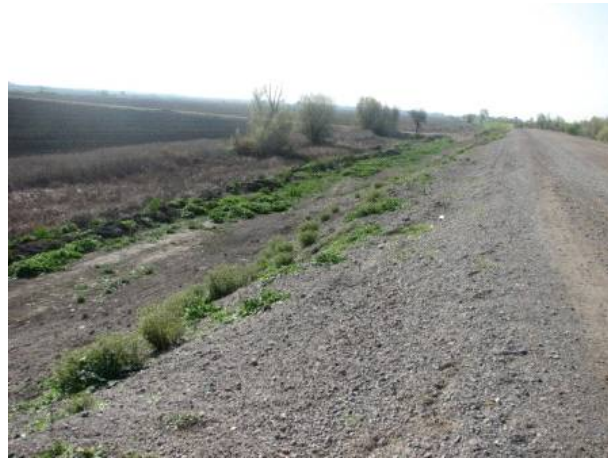
Levee Mile Report Line	7
Start Levee Mile	0.52
End Levee Mile	0.52
Location	Land Side
Category	
Item	Slope Stability

Buldge at the landside toe of the levee, photos taken spring 2012.

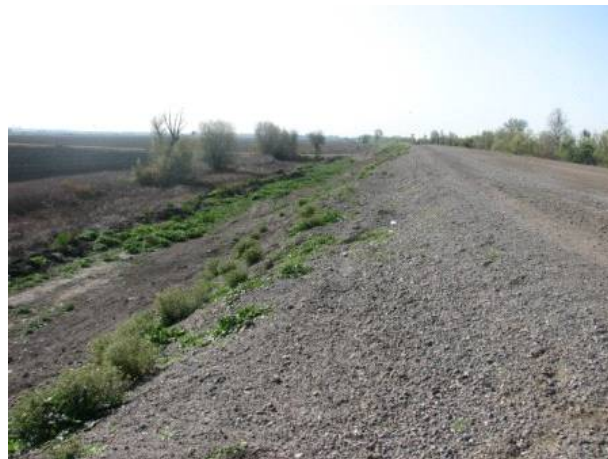
Levee Mile Report Line	7
Start Levee Mile	0.52
End Levee Mile	0.52
Location	Land Side
Category	
Item	Slope Stability

Slope instability at shoulder of landside levee buldge at toe.

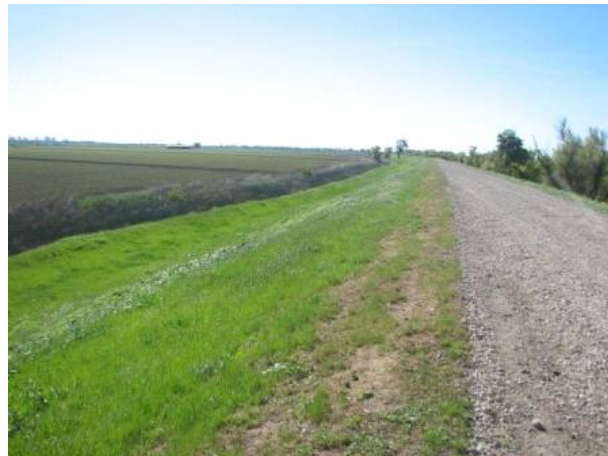
Levee Mile Report Line	8
Start Levee Mile	0.64
End Levee Mile	3.29
Location	Land Side
Category	
Item	Vegetation

The goats have done a good job. Spring 2013

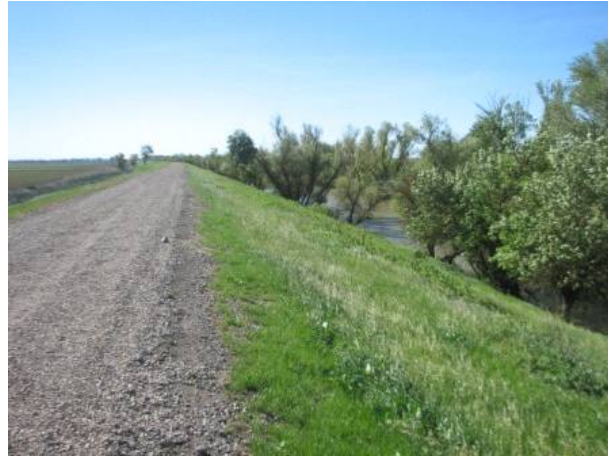
Levee Mile Report Line	9
Start Levee Mile	0.64
End Levee Mile	3.29
Location	Water Side
Category	
Item	Vegetation
The goats have eaten the vegetation down. Spring 2013	
johngw_s_20130415_931.JPG

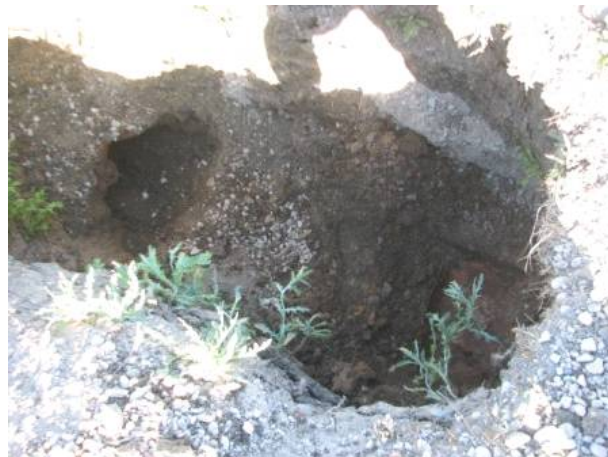
Levee Mile Report Line	10
Start Levee Mile	1.08
End Levee Mile	1.08
Location	Crown
Category	
Item	Encroachments
A view of the damaged pipe. The owners have applied for a permit. Spring 2013	
johngw_s_20130415_932.JPG

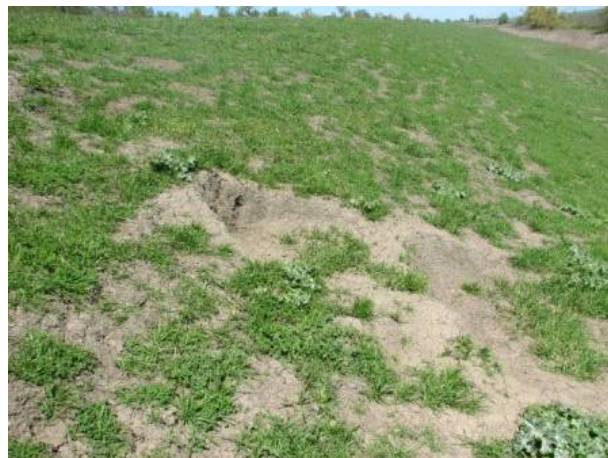
Levee Mile Report Line	11
Start Levee Mile	2.20
End Levee Mile	2.20
Location	Land Side
Category	
Item	Slope Stability
There is slope instability with three step like spots. The cuts are 1' to 1.5' deep. Photo taken spring 2012.	
johngw_s_20130221_428.jpg

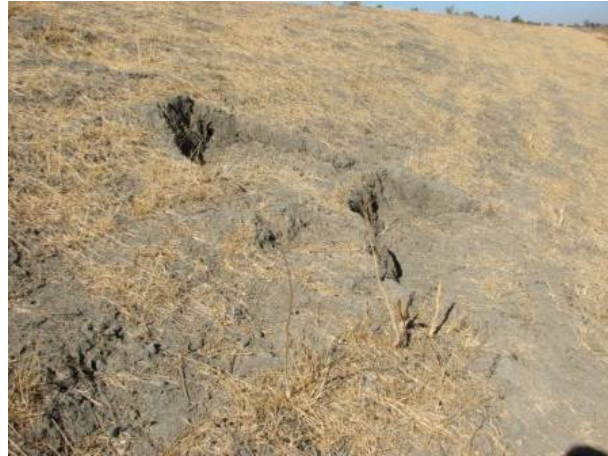
Levee Mile Report Line	11
Start Levee Mile	2.20
End Levee Mile	2.20
Location	Land Side
Category	
Item	Slope Stability

Slope instability. Photo fall 2012.

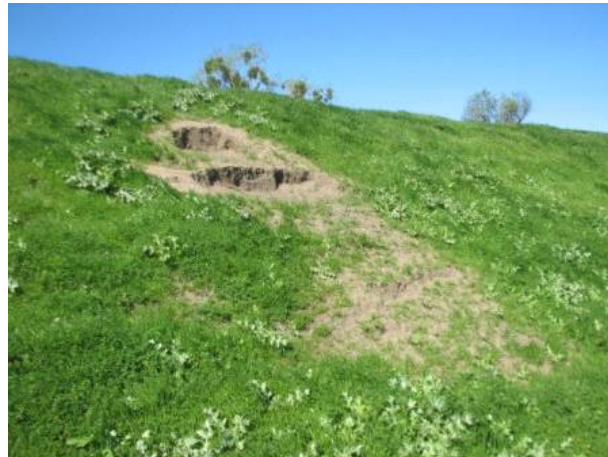
Levee Mile Report Line	11
Start Levee Mile	2.20
End Levee Mile	2.20
Location	Land Side
Category	
Item	Slope Stability

Slope instability is still there. Spring 2013
